Model 1200, 1240, 1242, 1242E, 1244, 1244E

PowerLuber Grease Gun

SERVICE PARTS

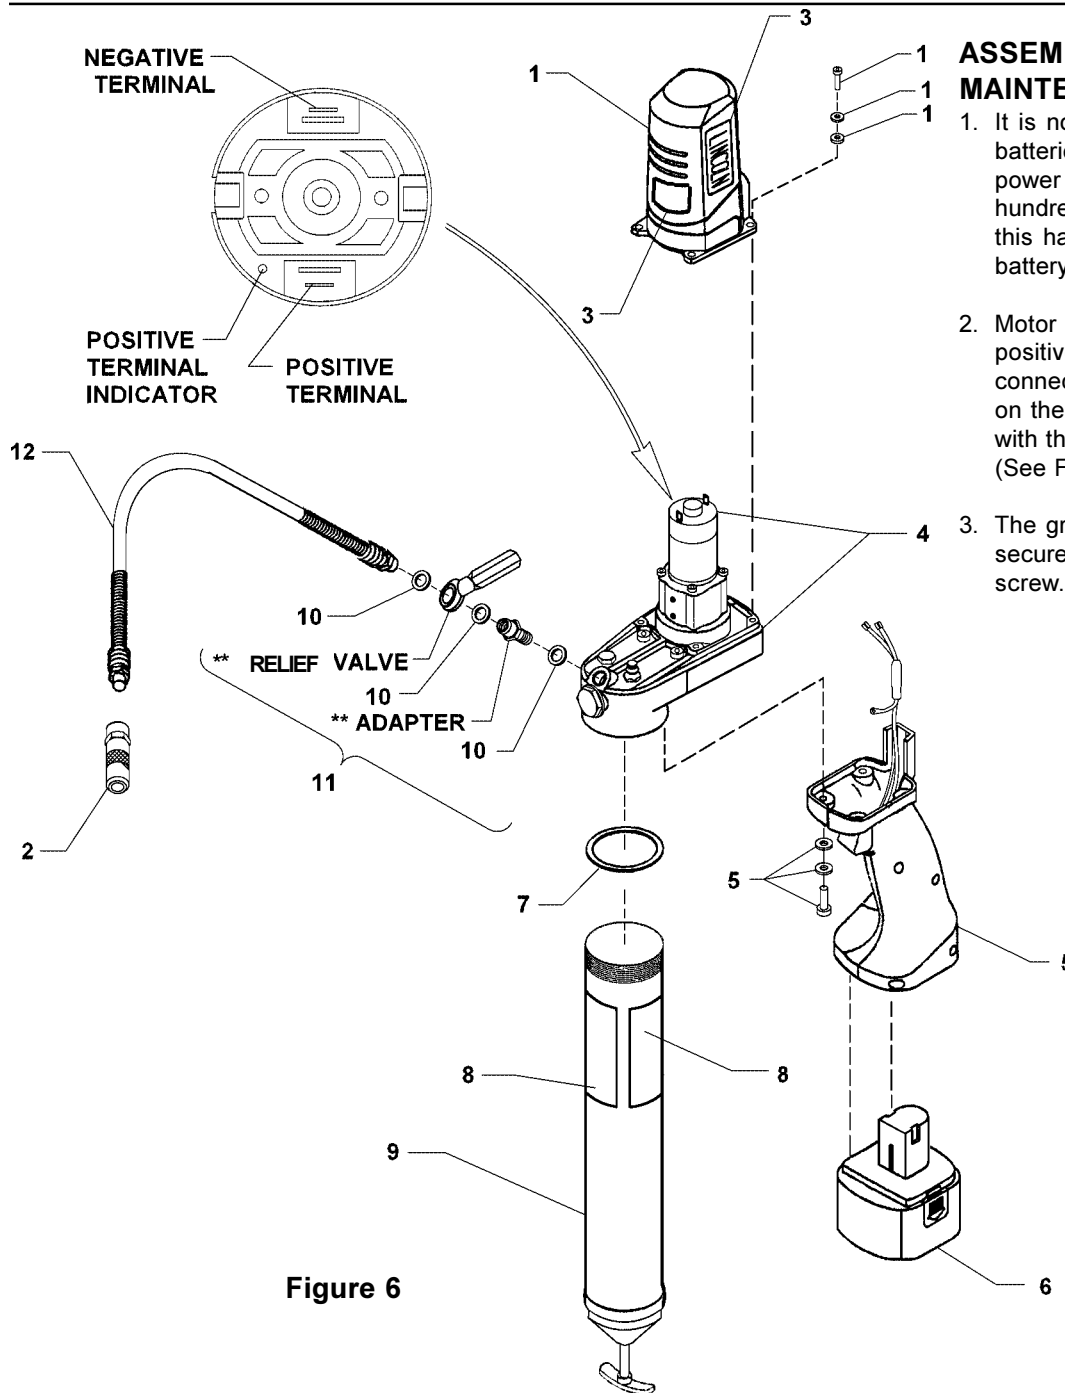
Figure 6

1. It is normal for nickel-cadmium batteries to gradually lose their power retention capacity over hundreds of charge cycles. When this happens replacement of the battery pack will be required.
2. Motor polarity is important, the positive, (red) wire must be connected to the positive terminal on the motor, which is identified with the small plastic dot next to it. (See Fig.6)
3. The green ground wire must be secured under the motor mounting screw.
